Diagnosis and Solutions for Bank Erosion Problems

This fact sheet describes frequently observed bank erosion problems and recommends installations to correct each situation. If major problems exist, experts should be consulted.

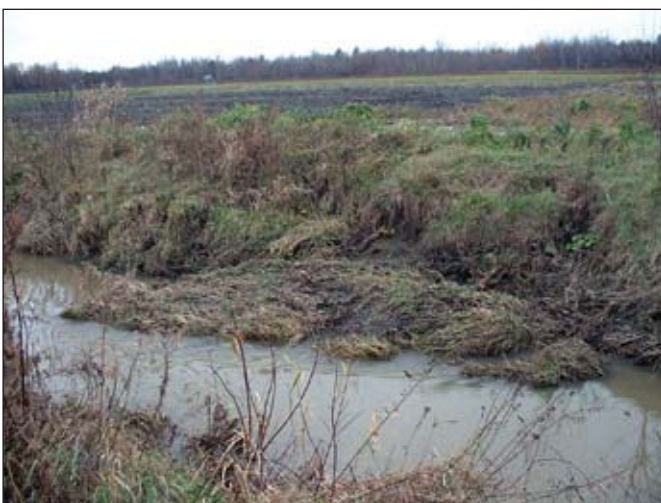
Photo 2: The effect of gravity
Source: Robert Beaulieu, MAPAQ

Slope failure occurs when the materials that make up the banks are no longer able to resist the forces of gravity. This mechanism occurs primarily in cohesive soils that are able to retain large quantities of water, which adds weight to the bank and reduces the cohesive forces between particles (lubrication). As a result, the slope becomes even more susceptible to failure.

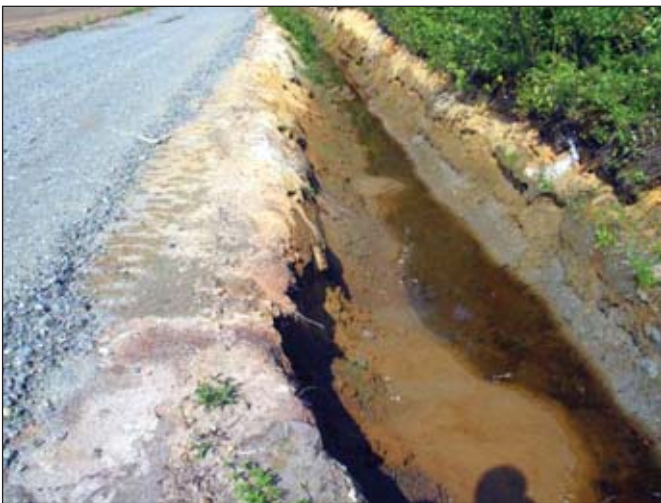
Photo 3: Piping caused by excavation of a stream in soil with an elevated water table
Source: Victor Savoie, MAPAQ

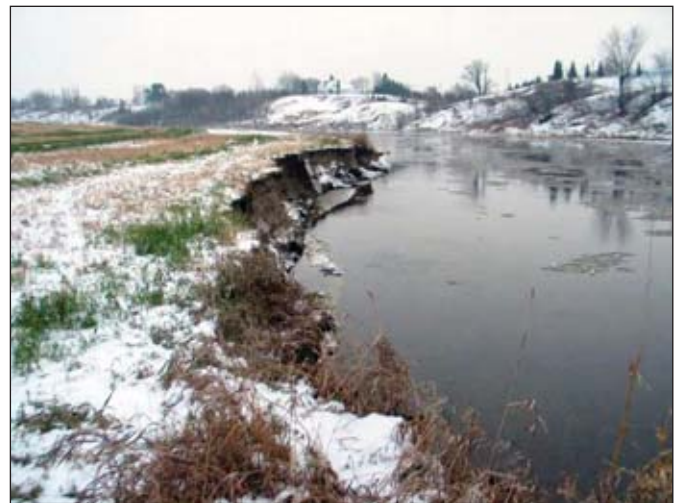
Photo 4: The erosive power of water
Source: Victor Savoie, MAPAQ

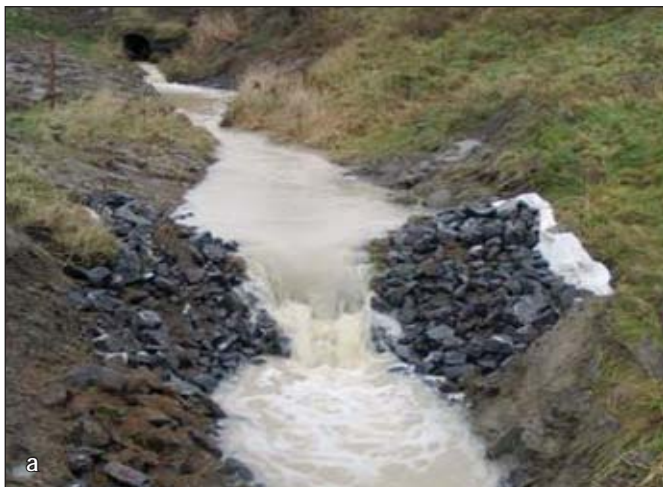
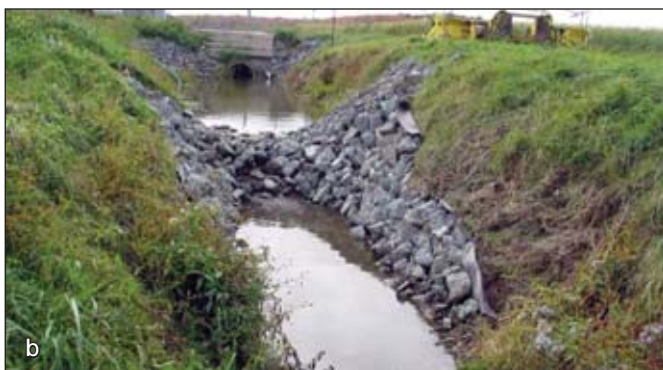
Photos 7 (a and b): Energy dissipating sill
Source: Jacques Goulet and Victor Savoie, MAPAQ

- Localized riprapping of the streambed.
- Energy dissipating sill to slow water flow.
- Channelling: Only in the case of a ditch.

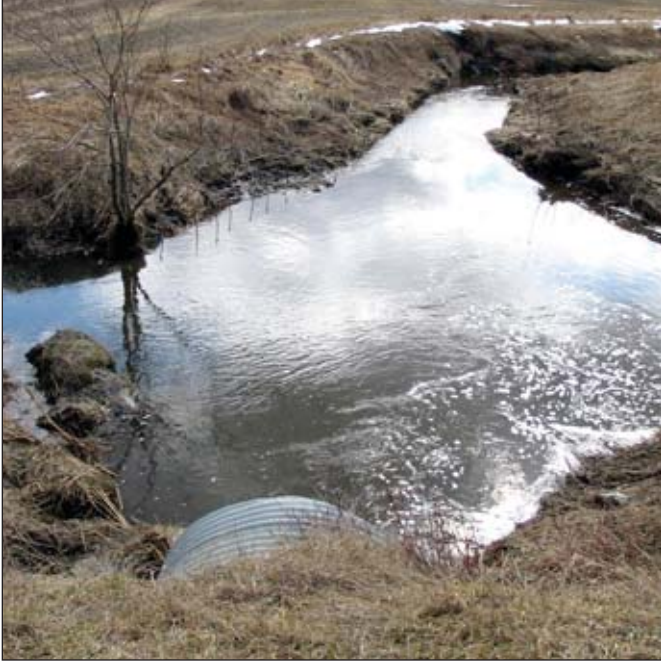
Photo 8: Widening of the streambed downstream of a culvert
Source: Mikael Guillou, MAPAQ

- Presence of pockets of erosion in the bank around the culvert.
- Widening and deepening of the streambed downstream.
- Upstream sedimentation.

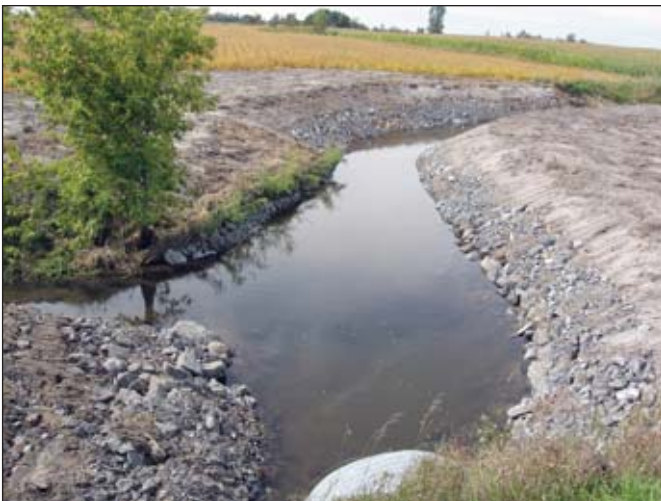
Photo 9: Protection upstream of the culvert
Source: Mikael Guillou, MAPAQ

- Re-sizing and replacement of the culvert.
- Protection of banks and culvert approaches.
- Regular inspection of the culvert and removal of debris that could obstruct it.

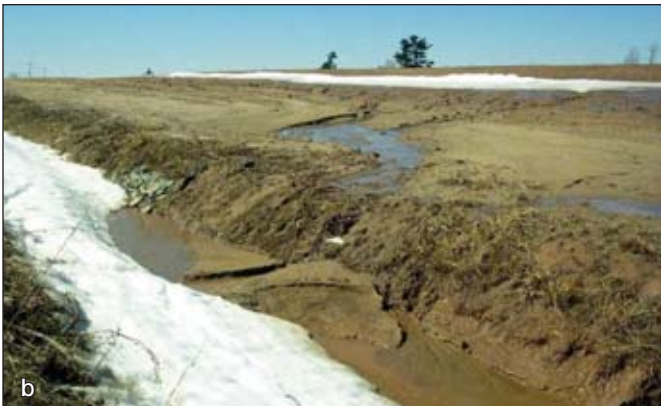
Photo 14 (a and b): Gullying originating in a field.
Source: Victor Savoie, MAPAQ

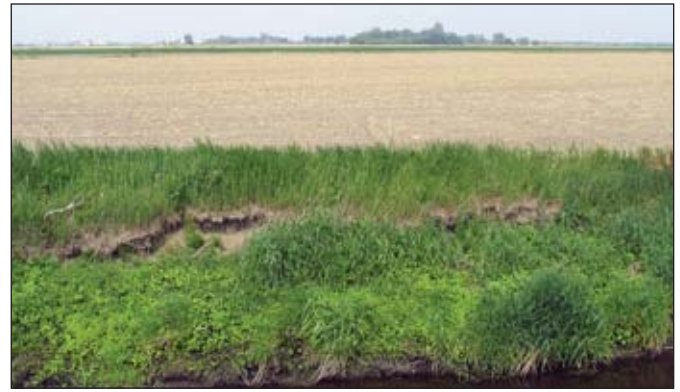
Photo 15: Bank failure.
Source: Robert Beaulieu, MAPAQ

- Often occurs in cohesive soils (clay or silty soil).
- Presence of soil at the toe of the bank.
- Circular arc failure in clay soils.
- Cracks parallel to the bank in silty or sandy soils.
- Presence of a furrow parallel to the streambank and in which water is accumulating.
- Vibrations and excessive loads.

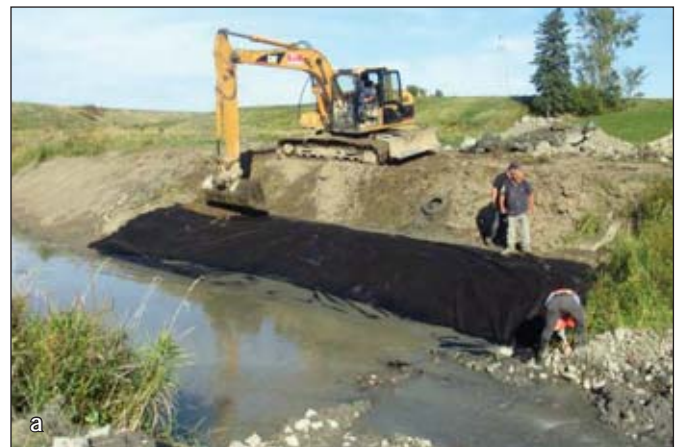
Photos 16 (a and b): Bank stabilization
Source: Victor Savoie, Ghislain Poisson, MAPAQ

- Reduce the slope, according to soil type.
- Install a drain parallel to the bank to lower the water table and capture the water from the furrows, thereby reducing pressure and preventing entrainment of soil particles.
- If the conditions do not allow the slope to be modified, the toe of the slope can be riprapped (in this case, a large riprap key rock will be required as a counterweight).
- Vegetate the bank (seed herbaceous vegetation, plant shrubs).

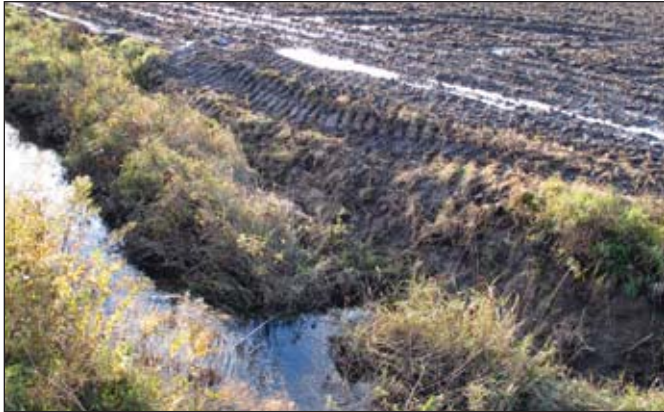
Photo 17: Failure caused by an excessive load
Source: Mikael Guillou, MAPAQ

Excessive loads can cause bank failure. Loads can be static, e.g., the weight of a tree or pile of soil, or dynamic (variable loads that cause vibrations), e.g., passing machinery. Tracked vehicles are particularly problematic.

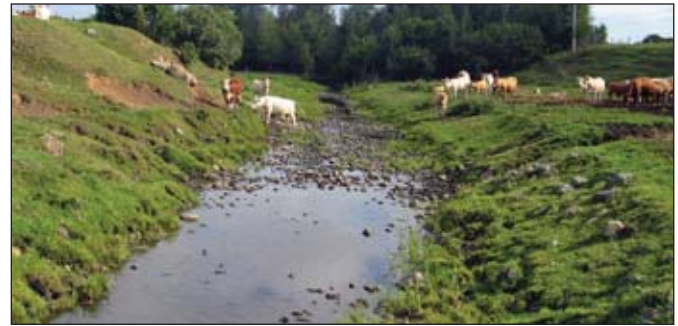
Photo 18: Trampling by livestock
Source: Mikael Guillou, MAPAQ

Because livestock hooves have a small load-bearing surface, they exert a significant amount of pressure on the soil. Livestock also have a tendency to always return to the same areas. By repeatedly using the same paths to access or cross streams, they destroy vegetation, weaken banks and initiate the formation of pockets of erosion. Streams used by livestock for watering can also be contaminated by excrement.

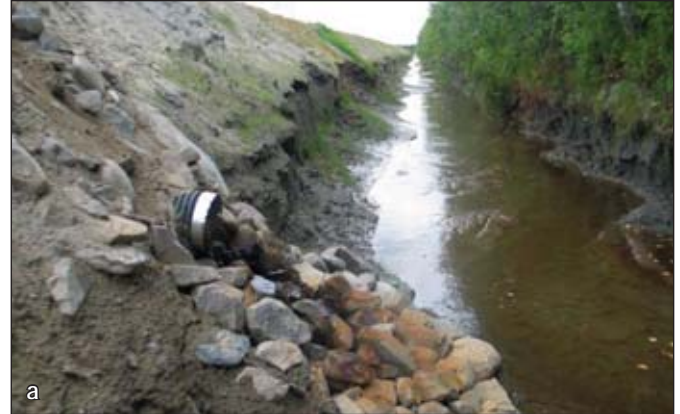
Photos 20 (a and b): Piping
Source: Victor Savoie, Robert Beaulieu, MAPAQ

- Soil stratification (permeable soil overlying a layer of less permeable soil).
- Presence of an elevated water table.
- Water seepage into the bank (before the soil collapses).
- Presence of wet areas without vegetation in the bank.
- Presence of mudflow.
