Diagnosis and Solutions for Bank Erosion Problems

This fact sheet describes frequently observed bank erosion problems and recommends installations to correct each situation. If major problems exist, experts should be consulted.

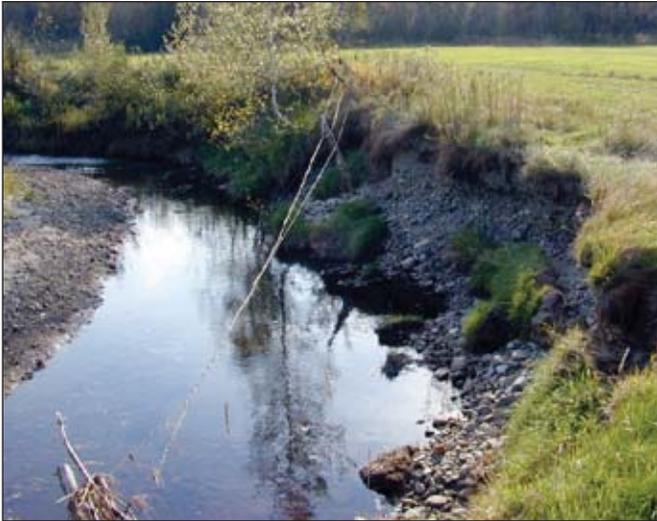
Photo 1: The erosive power of water
Source: Luc Lemieux, MAPAQ

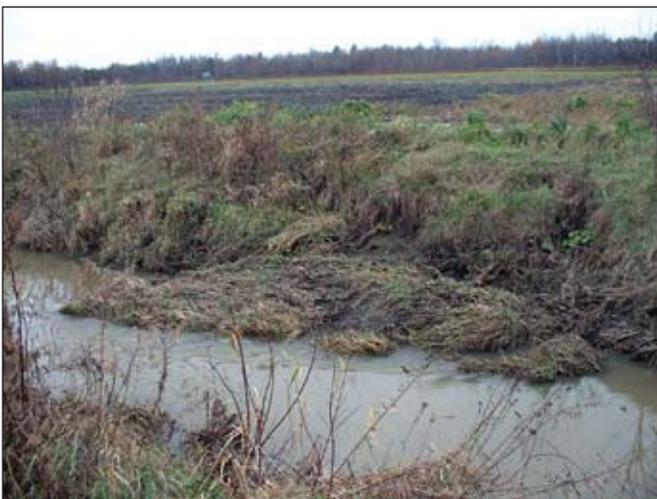
Photo 2: The effect of gravity
Source: Robert Beaulieu, MAPAQ

Slope failure occurs when the materials that make up the banks are no longer able to resist the forces of gravity. This mechanism occurs primarily in cohesive soils that are able to retain large quantities of water, which adds weight to the bank and reduces the cohesive forces between particles (lubrication). As a result, the slope becomes even more susceptible to failure.

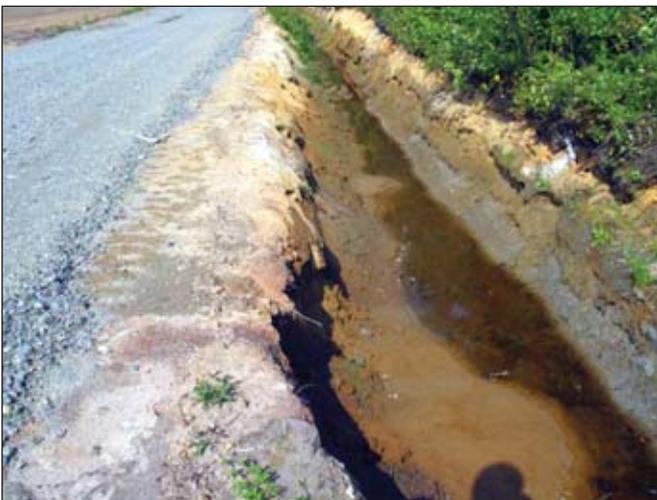
Photo 3: Piping caused by excavation of a stream in soil with an elevated water table
Source: Victor Savoie, MAPAQ

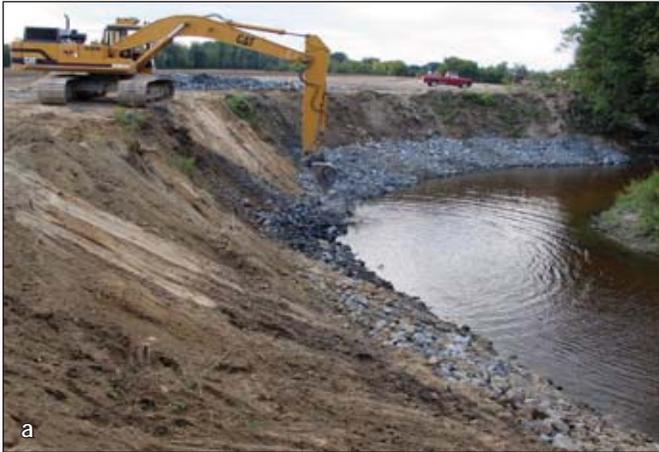
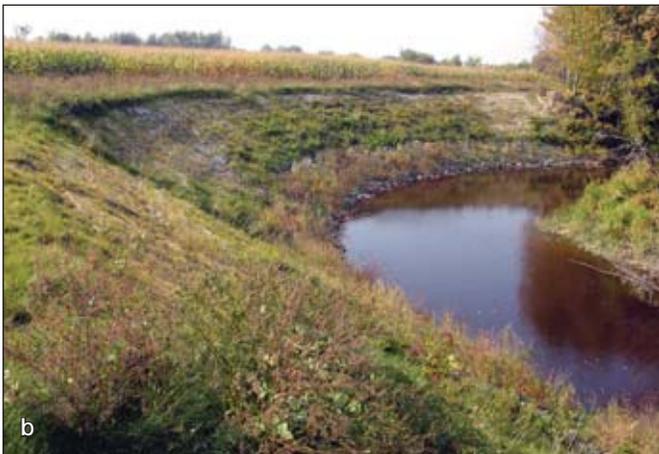
Photos 5 (a, b): Installations in a bend
Source: Mikael Guillou MAPAQ

- In all cases, plant shrubs and/or perennials at the top of the bank.
- Reduce water flow by installing energy dissipating sills.
- In bends:
 - Round out bends before establishing protection.
 - Build rock or willow pole groins (other techniques also exist) to divert the current toward the centre of the stream.

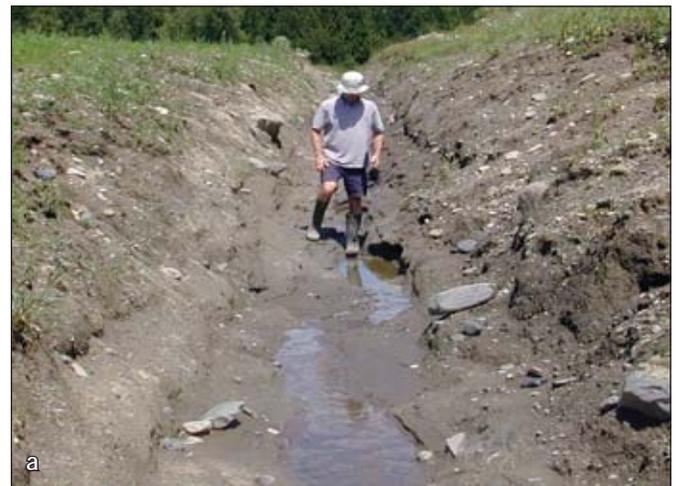
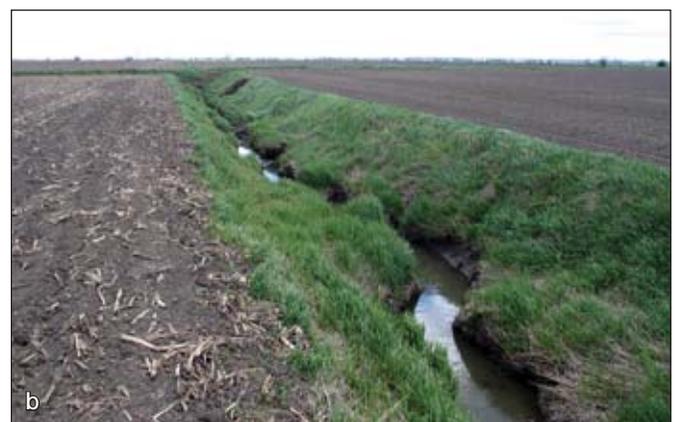
Photos 6 (a and b): Downcutting
Source: Luc Lemieux and Mikael Guillou, MAPAQ

- Streambed deepening (compared with previous longitudinal profiles).
- Signs of meanders and sedimentation in the bed during low-flow periods.
- Rapid flow, where water is present.
- If a culvert is present: a vertical wall at the culvert outlet (downstream).
- Exposed roots (to differentiate from undercutting).
- Slumping of both banks, particularly along a straight line.
- No aquatic vegetation or sedimentation.
- Steep slope and deep soil (no bedrock).
- Soil layer change in the streambed.
- Formation of a deepened bed in the centre of the stream, with vertical banks (see Figure 4 and Photo 6).

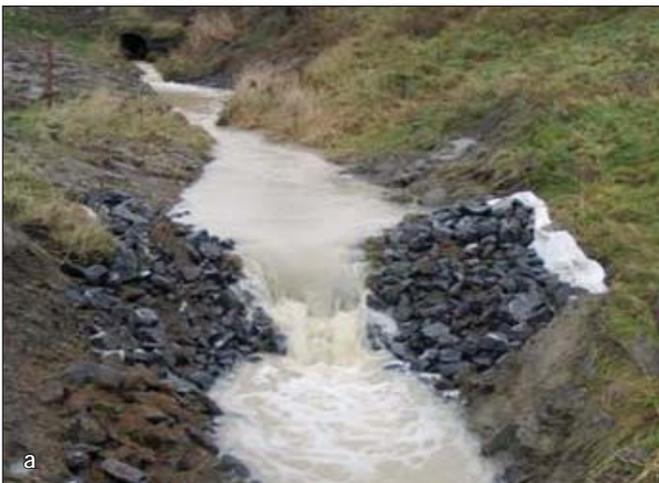
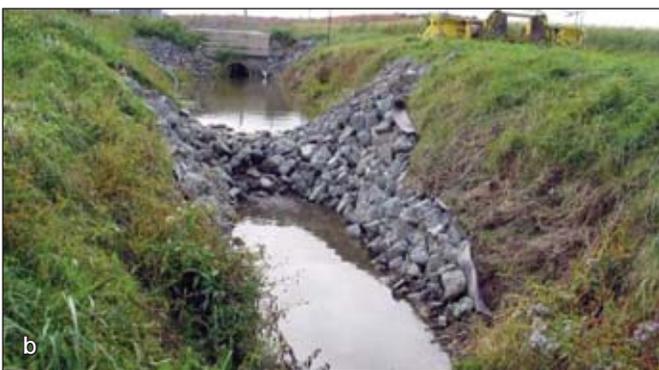
Photos 7 (a and b): Energy dissipating sill
Source: Jacques Goulet and Victor Savoie, MAPAQ

- Localized riprapping of the streambed.
- Energy dissipating sill to slow water flow.
- Channelling: Only in the case of a ditch.

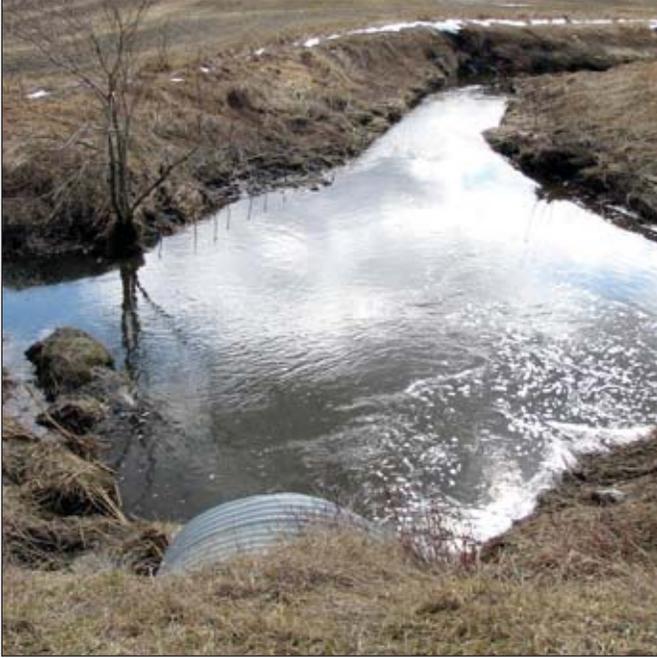
Photo 8: Widening of the streambed downstream of a culvert
Source: Mikael Guillou, MAPAQ

- Presence of pockets of erosion in the bank around the culvert.
- Widening and deepening of the streambed downstream.
- Upstream sedimentation.

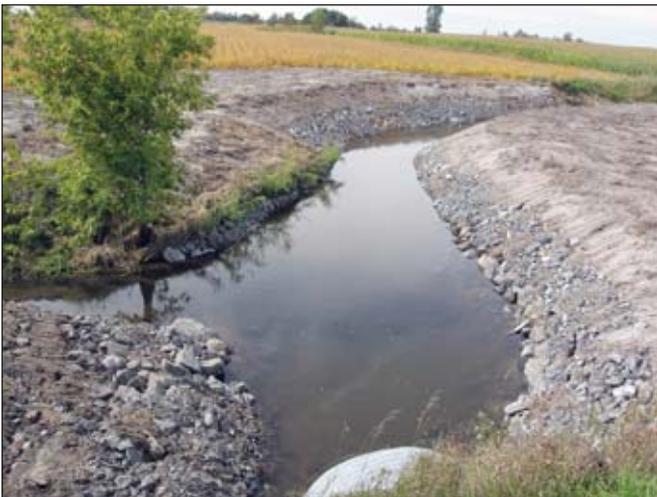
Photo 9: Protection upstream of the culvert
Source: Mikael Guillou, MAPAQ

- Re-sizing and replacement of the culvert.
- Protection of banks and culvert approaches.
- Regular inspection of the culvert and removal of debris that could obstruct it.

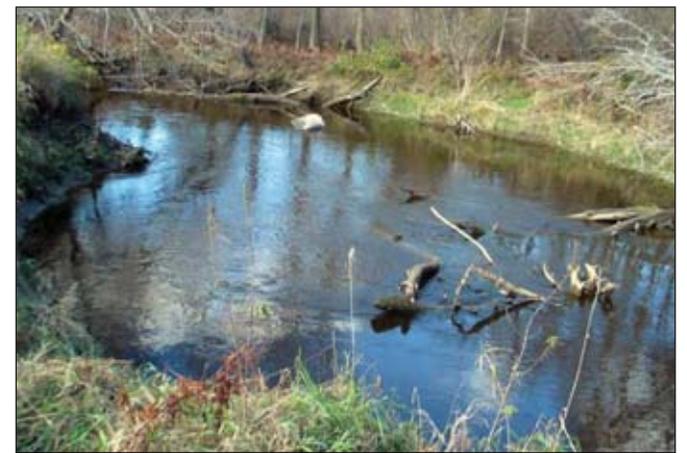
Photo 10: Bank erosion caused by an obstruction in the streambed.
Source: Victor Savoie, MAPAQ

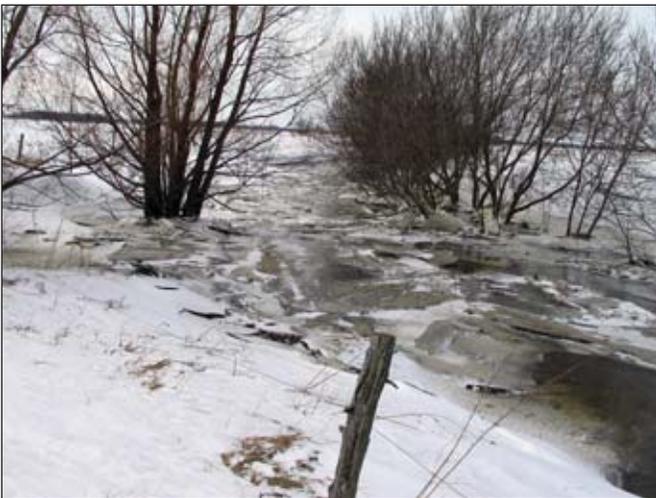
Photo 11: Ice erosion
Source: Mikael Guillou, MAPAQ

In the spring, the ice cover breaks into pieces, forming sharp edges. Carried by strong currents, these sharp edges strike the banks, scarifying the surfaces. Bends are particularly vulnerable to this phenomenon.

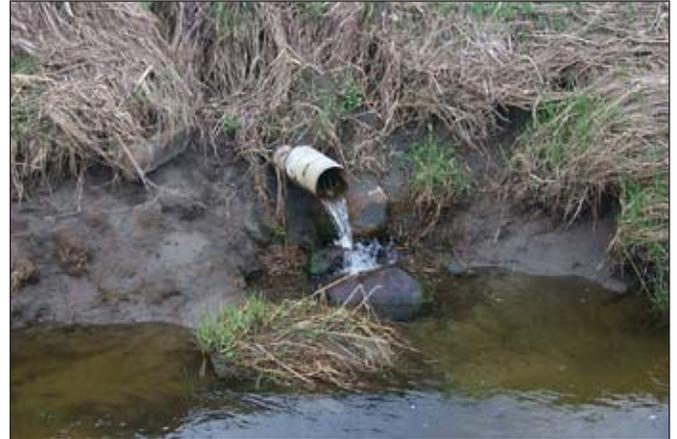
Photo 12: Erosion at a drain outlet
Source: Mikael Guillou, MAPAQ

- The soil around and under the drain outlet is eroded.
- The drain outlet may be detached, blocked, sunken or buried.
- The opposite bank is damaged.

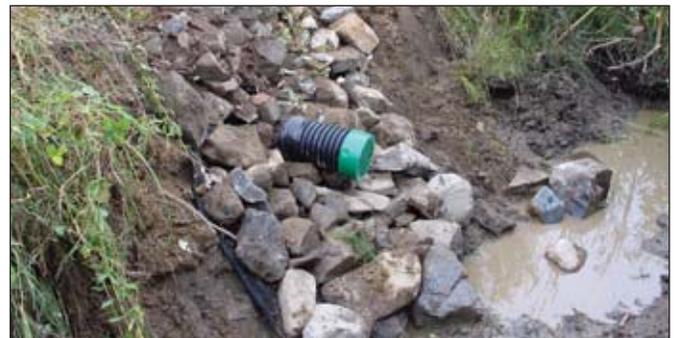
Photo 13: Erosion protection at a drain outlet
Source: Mikael Guillou, MAPAQ

- Clean drain outlets regularly.
- Protect them against erosion.
- Protect them from rodents.
- Put in place an identification system to facilitate regular maintenance of drain outlets and to prevent them from being damaged if any work is carried out in the stream.

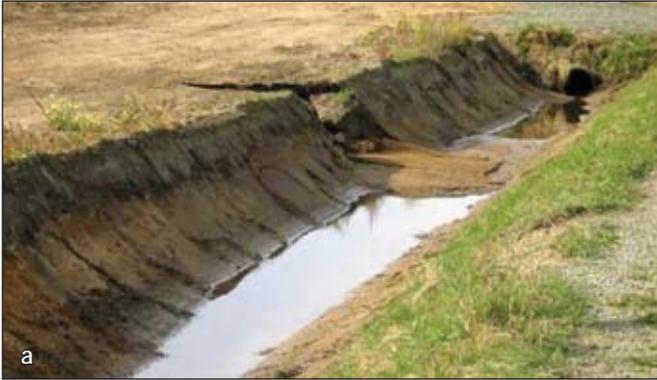
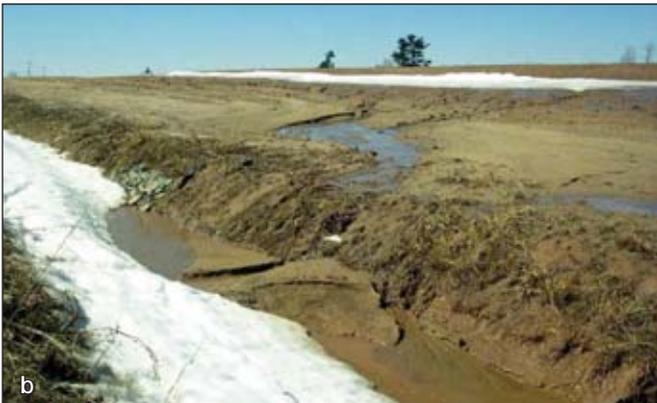
Photo 14 (a and b): Gullying originating in a field.
Source: Victor Savoie, MAPAQ

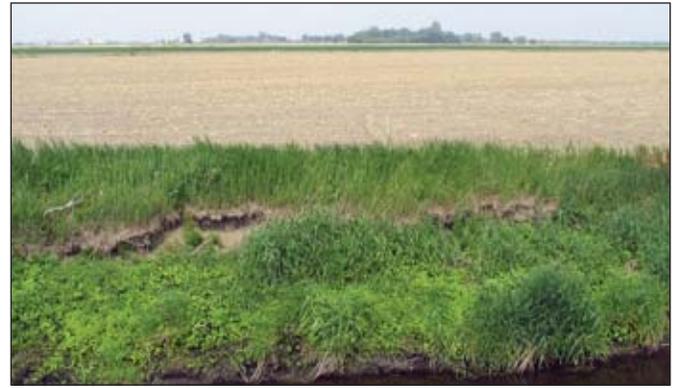
Photo 15: Bank failure.
Source: Robert Beaulieu, MAPAQ

- Often occurs in cohesive soils (clay or silty soil).
- Presence of soil at the toe of the bank.
- Circular arc failure in clay soils.
- Cracks parallel to the bank in silty or sandy soils.
- Presence of a furrow parallel to the streambank and in which water is accumulating.
- Vibrations and excessive loads.

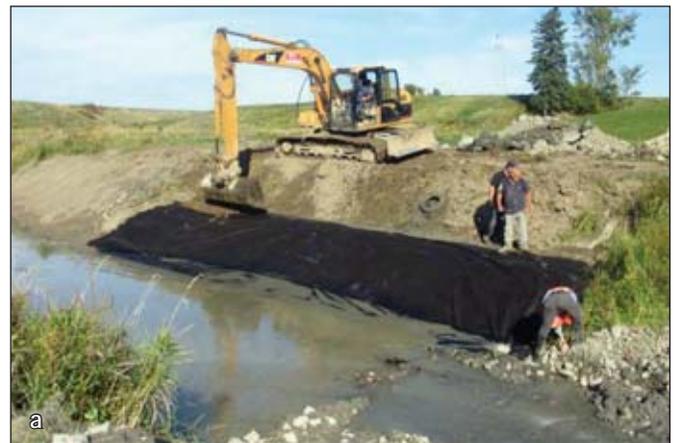
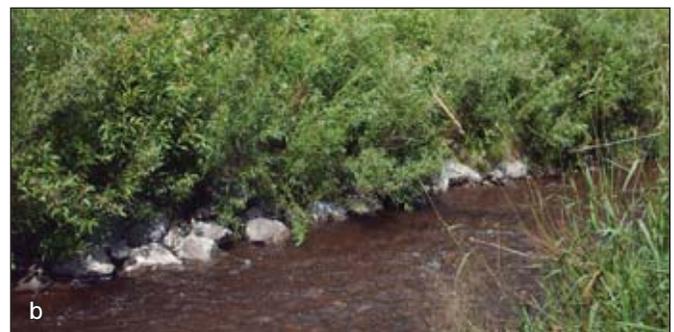
Photos 16 (a and b): Bank stabilization
Source: Victor Savoie, Ghislain Poisson, MAPAQ

- Reduce the slope, according to soil type.
- Install a drain parallel to the bank to lower the water table and capture the water from the furrows, thereby reducing pressure and preventing entrainment of soil particles.
- If the conditions do not allow the slope to be modified, the toe of the slope can be riprapped (in this case, a large riprap key rock will be required as a counterweight).
- Vegetate the bank (seed herbaceous vegetation, plant shrubs).

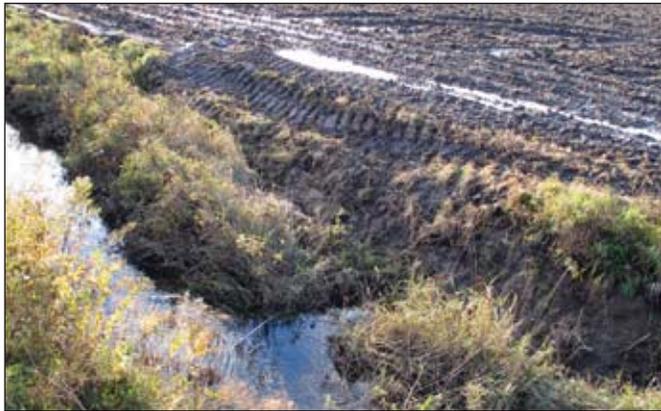
Photo 17: Failure caused by an excessive load
Source: Mikael Guillou, MAPAQ

Excessive loads can cause bank failure. Loads can be static, e.g., the weight of a tree or pile of soil, or dynamic (variable loads that cause vibrations), e.g., passing machinery. Tracked vehicles are particularly problematic.

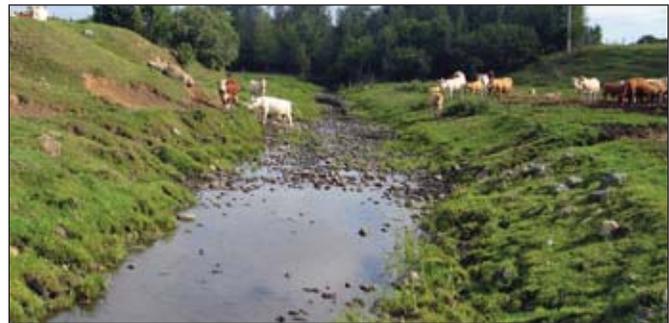
Photo 18: Trampling by livestock
Source: Mikael Guillou, MAPAQ

Because livestock hooves have a small load-bearing surface, they exert a significant amount of pressure on the soil. Livestock also have a tendency to always return to the same areas. By repeatedly using the same paths to access or cross streams, they destroy vegetation, weaken banks and initiate the formation of pockets of erosion. Streams used by livestock for watering can also be contaminated by excrement.

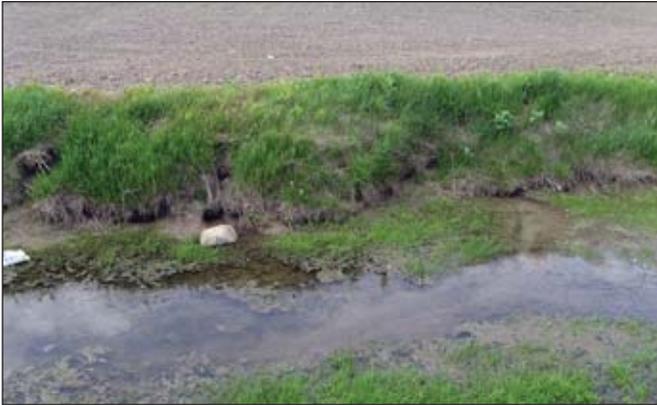
Photo 19: Burrows in banks
Source: Nicolas Stampfli

Particular attention should be given to muskrat burrows. Because one of the access routes to a muskrat burrow is always located below the water level, the pressure exerted by flooding can cause large amounts of water to easily enter the burrows. Furthermore, since muskrats prefer to live in colonies, long sections of banks can become riddled with tunnels.

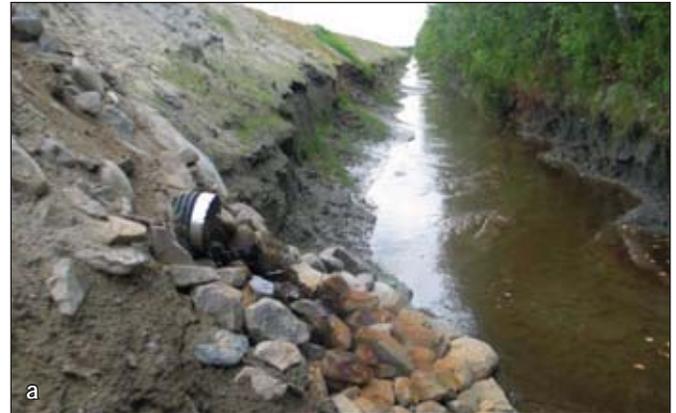
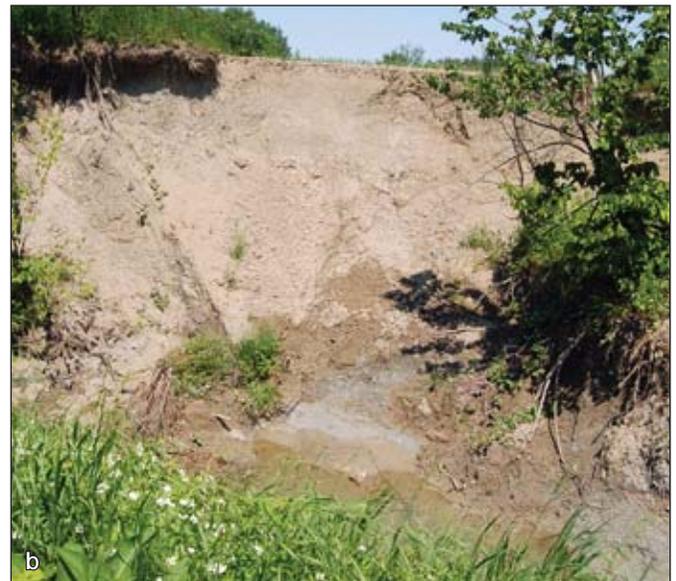
Photos 20 (a and b): Piping
Source: Victor Savoie, Robert Beaulieu, MAPAQ

- Soil stratification (permeable soil overlying a layer of less permeable soil).
- Presence of an elevated water table.
- Water seepage into the bank (before the soil collapses).
- Presence of wet areas without vegetation in the bank.
- Presence of mudflow.
